RADC-TR-78-226 Final Technical Report November 1978

RELIABILITY STUDY OF MICROWAVE TRANSISTORS UNDER TRANSIENT AND MISMATCHED LOADS

General Electric Company

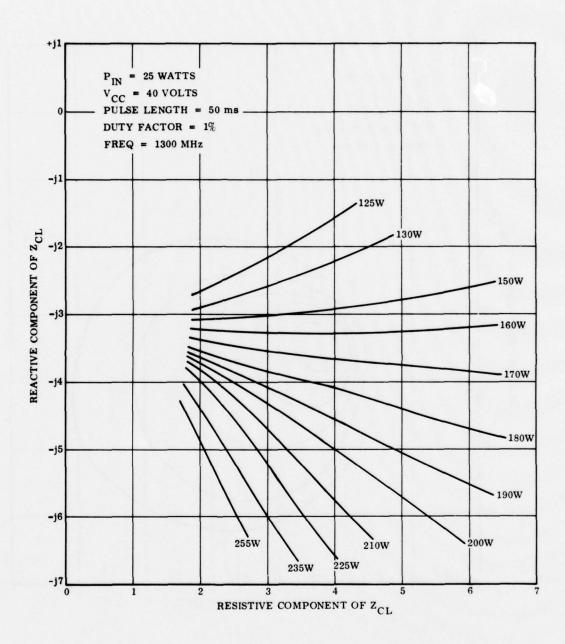
Figure 13. Constant P diss Contours for Device 1 (Serial No. 3)

Sets of power output, power dissipated and peak junction temperature contours were obtained for two units, under each of the test conditions listed in Table IV. A partial set of these contours is shown in Figures 12 through 15 for V_{cc} = 40 volts and P_{in} = 25.

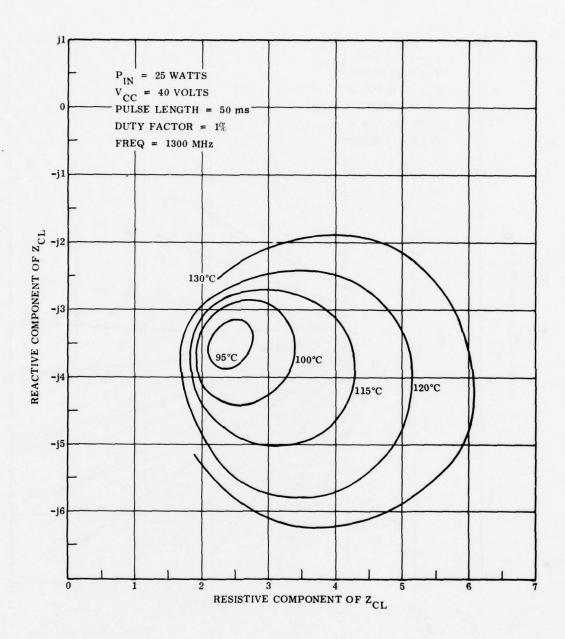
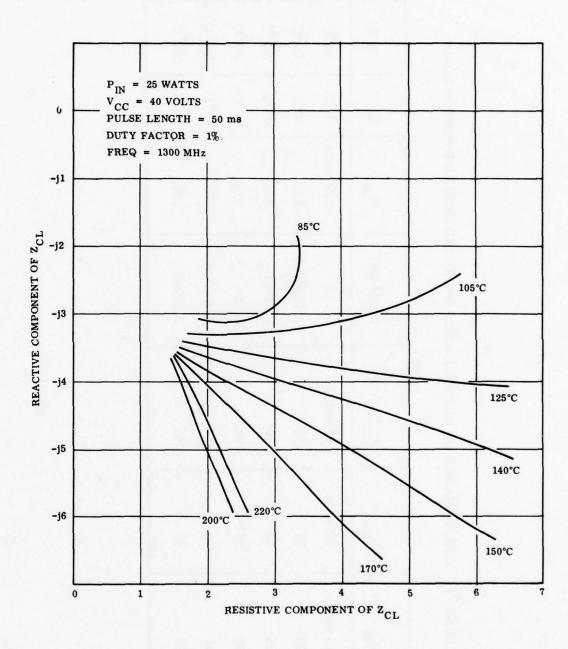
While, normally, it is sufficient to record only the junction temperature of the hottest cell, it was necessary to monitor the peak junction temperature for two adjacent cells of Device 1, because of an anomalous transistor temperature profile that was observed. Profiling the 28-cell transistor revealed that the cell temperature alternated from hot to cool from cell to cell. Further, it was observed that the position of the hottest cell varied between two cells at one end of the chip. These cells are designated cells 1 & 2 for convenience. Also, the T_j contours for the two cells follow quite a different pattern. This is accounted for by noting that, although the cells are not physically separated from one another, the separation is sufficient to transform the collector load differently to each cell. Of greater consequence, however, is the fact that each cell is fed by the same emitter wire. This results in cells that are either inside or outside an emitter wire. If the junction temperature profiles are plotted separately, for the cells located toward the interior and exterior side of an emitter wire, two distinct profiles that fluctuate with load are observed. While no clear explanation has been found for these phenomena, it appears that the cells interior to an emitter wire are loaded differently than those located exterior to a wire. If the device was more heavily ballasted, this anomalous behavior may not have occurred.

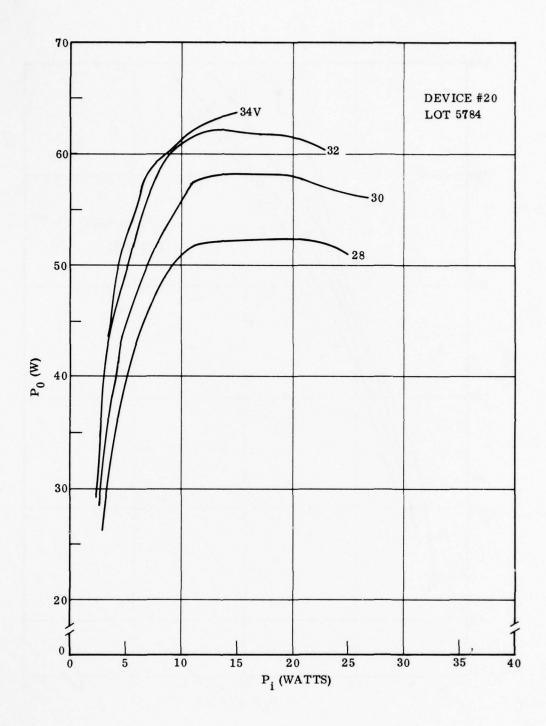
Figure 37 Output Power versus Input Power for Device 5784-20

In order to evaluate the behavior of the devices under short pulse, high-drive and high-voltage conditions, in more detail, a series of characterization tests were done, with the devices mounted in the test fixture. Figures 37 and 38 present the results for device 5784-#20. In figure 37 the output power is plotted as a function of the input power for several values of collector voltage. In Figure 38 the junction temperature is plotted versus the input power for several values of $V_{\rm cc}$. Figure 37 indicates that the device is saturated for drives above about 11 watts. Increasing the collector voltage increases the power out at saturation; however, above 32 volts the increase in power is very small. The device failed at $V_{\rm cc}$ = 34 volts, when the drive was increased from 15 to 17 watts. Figure 38 indicates that the rate of rise of junction temperature with drive was increasing under these conditions and that failure probably results from thermal runaway. Several other devices were characterized with similar results.

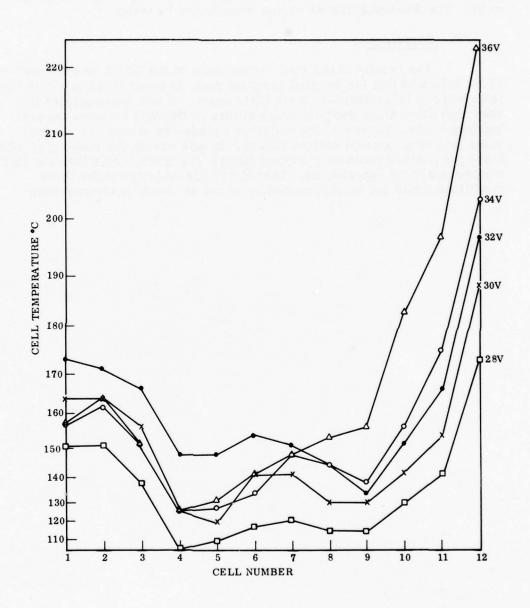
Figure 39 Variation of Cell Temperature Distribution With Collector Voltage

As part of the device characterization in the Laboratory, the temperatures of the different cells were measured as the collector voltage was increased. This was done for several different devices. The results are presented in Figure 39 for a typical device. Invariably, the end cell (#12) is significantly hotter than the rest at 28V. The other end cell (#1) is also hotter than the interior cells. As the voltage is increase, cell #12 remains hottest, but there is some variation in the relative temperature of the other cells. The detailed behavior varies from device to device.

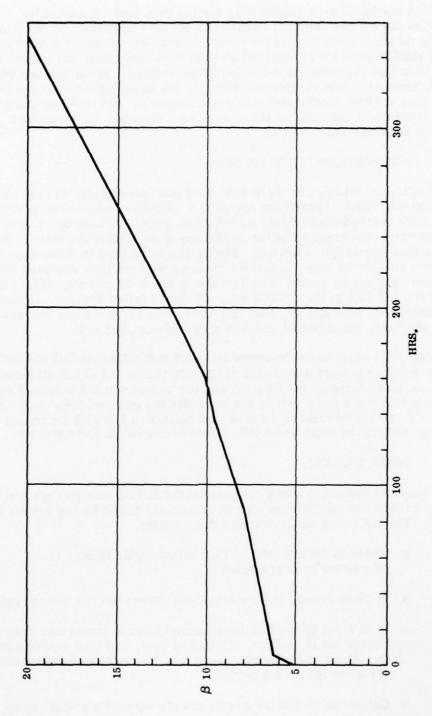
Figure 52. Gain Recovery versus Time at 225°C for Device No. 5782-21

allowing charge redistribution and a resulting increase in surface leakage, which leakage causes gain reduction.
